JOHNSON COUNTY, INDIANA

Americans with Disabilities Act Self-Evaluation and Transition Plan

May 2015

Project No. 1263.0874.90

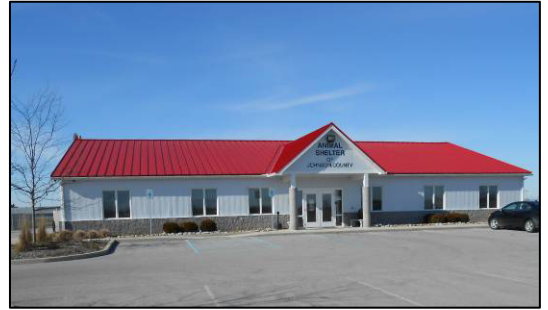
- Barrier free parking has minor slope deviations and lack sufficient markings.
- Door closers frequently do not meet closing speed requirements.
- Accessible service counter is not provided.
- Maneuvering space is not sufficient in cat adoption room.
- Restroom exhibits a number of minor dimensional deviations, including location of grab bars, electrical components, and dispensers. Appropriate signage is not provided.

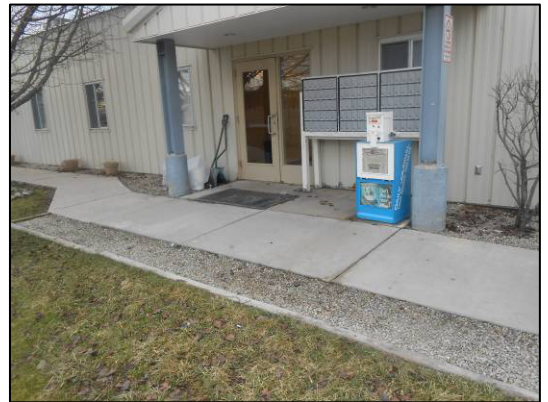
Community Corrections

- Barrier free parking lacks sufficient markings and signage.
- Curb ramp exceeds allowable slopes.
- Door closers frequently do not meet closing speed or operating force requirements.
- Accessible drinking fountain is not provided.
- Accessible testing station is recommended.
- Restroom exhibits a number of minor dimensional deviations, including location of grab bars and dispensers. Required maneuvering space is blocked by sink. Appropriate signage is not provided.

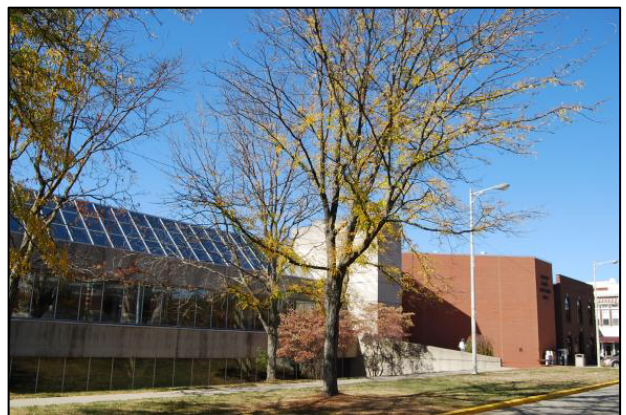
Courthouse Annex

- Barrier free parking has minor slope deviations and lacks sufficient markings and signage.
- Door closers frequently do not meet closing speed or operating force requirements. A number of doors have hardware that require grasping and twisting.
- Accessible routes to building are limited due to steep slopes and presence of stairs.
- Hi-Lo fountains are not provided.
- Lack of a kick plate on glass doors is frequently cited.
- Electrical components are generally too high.
- Accessible service counters are not provided at a number of departments.
- Restroom exhibits a number of minor dimensional deviations, including location of grab bars, electrical components, mirrors and dispensers. Waterlines are not insulated. Appropriate signage is not provided. Multi-user restrooms lack adequate stall width.

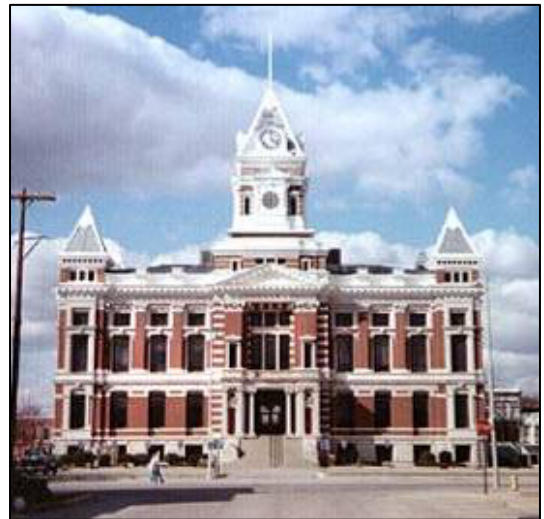
- First, Second and Third floor restrooms present a variety of deficiencies including but not limited to, insufficient stall width, lack of handles, lack of insulation on waterlines, non-compliant faucet controls, no rear grab bar, non-compliant flush controls, and incorrect mounting heights for dispensers and coat hooks.

- Courts do not provide or identify accessible aisle seating or companion seating. Assistive listening devices are lacking.
- Jury restrooms lack overall dimension to provide turning space and clear spaces required. No accessible features (such as grab bars) are provided.
- Door width at Magistrate's office is of insufficient width.
- Elevator exhibits non-compliances including, lack of floor indicators, hallway signals, and various issues with emergency controls and communication, but is generally useable by persons of all abilities.
- Stairways lack signage and provide non-compliant handrails. The main stair has variable width treads. Both stairs exceed maximum riser height. Doorways to stairwells exceed operating effort, glazing panel height, and hardware requires pinching.

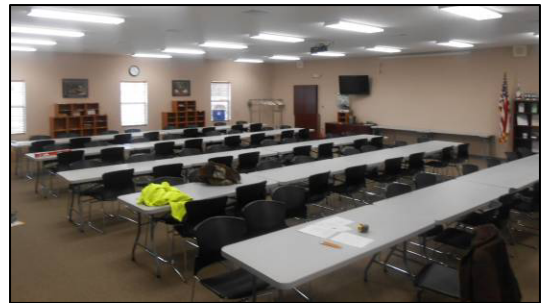
- Barrier free parking is not provided.
- Curb ramp does not provide landing and exceeds slope requirements.
- Portions of sidewalk exceed allowable cross slope.
- Door closers frequently do not meet closing speed or operating force requirements.
- Lack of a kick plate on glass doors is cited.
- Wall signage is not provided or does not meet requirements.
- Accessible kitchen components are not provided.
- Restroom exhibits a number of minor dimensional deviations, including location of grab bars, electrical components, mirrors and dispensers. Grab bars are not provided in unisex restroom. Waterlines are not insulated. Storage unit blocks required maneuvering space.

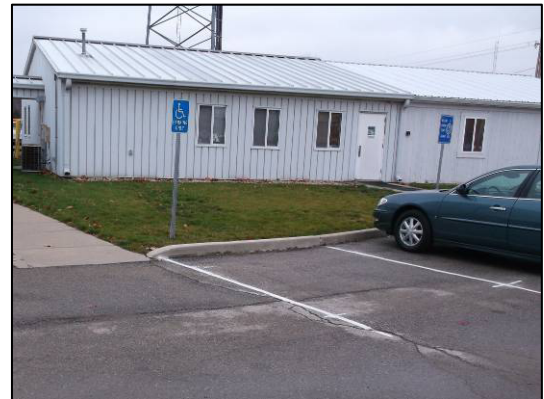
County Highway Department

- Barrier free parking does not provide signage or access aisle.
- Curb ramp is not provided at main entry.
- Door hardware is not compliant. Door closers frequently do not meet closing speed or operating force requirements.
- Wall signage is not provided or does not meet requirements.
- Hi-Lo fountain is not provided.
- Accessible service counter is not provided.
- Maneuvering space is insufficient at corridors.
- Furniture frequently limits turning space in rooms.
- Restroom exhibits a number of minor dimensional deviations, including location and dimension of grab bars, electrical components, mirrors and dispensers. Waterlines are not insulated. Clear width at toilets is obstructed by sink.

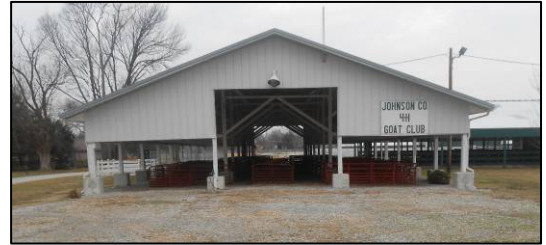
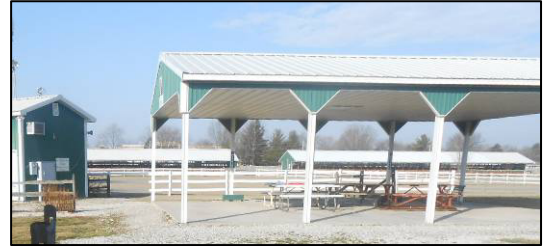
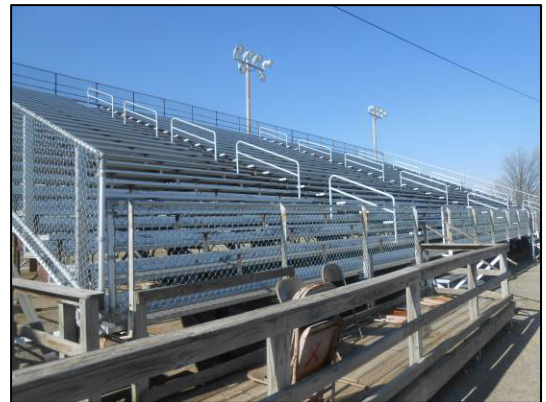
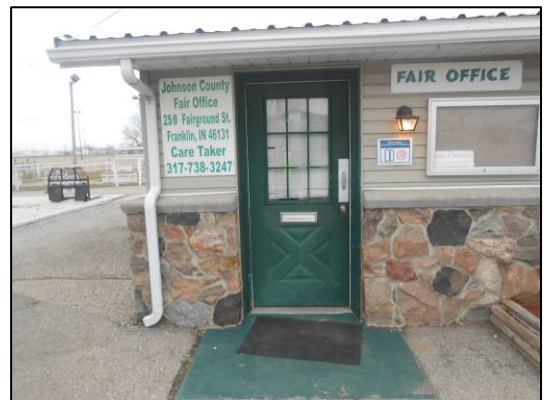
- Farm Bureau Building - Door hardware requires twisting and grasping and all entrances require step up from adjacent route.
- Fitzpatrick Hall - Exterior doors exceed threshold height and hardware requires twisting and grasping. Protruding objects need protection and electrical components are outside of reach range.

- Heritage Hall - Barrier free parking is not provided in gravel parking area. No accessible route is provided to entries or to Garden. Doors have excessive closing speed and glazing panels are over allowable height. Electrical components are outside of reach range. Drinking fountain does not meet requirements for standing persons or wheelchair users. Protruding objects (fire extinguishers) need protection. Restrooms lack compliant signage and door hardware. Mirror and dispensers are located outside of allowable heights. Lavatory obstructs clear space at toilet.

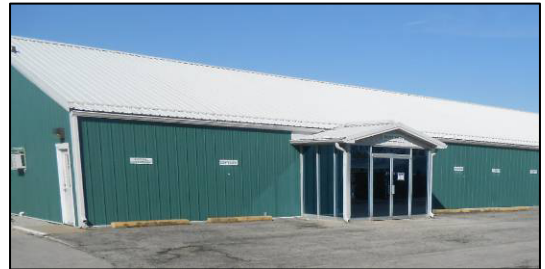
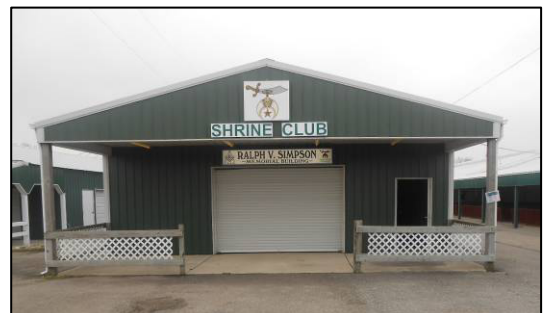
- Shooting Sports - Doors exceed maximum threshold height, lack sufficient width, and door hardware requires pinching.
- Shrine Club - Door hardware requires twisting and grasping, and light switches and counter are too high.

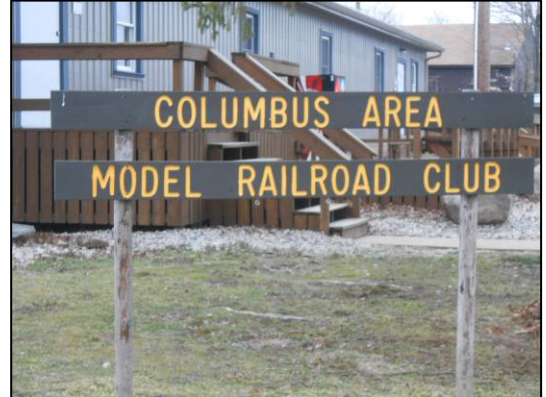
- Columbus Area Model Railroad Club - Accessible parking is not provided. Wood ramp does not connect to accessible route, provide edge protection, or have adequate handrails. Stairs do not have adequate handrails and bottom landings are gravel. Site furnishings are not on accessible route and benches do not provide compliant dimensions. Thresholds at doors are over allowable height. Electrical components are outside of reach range. Kitchenette does not provide adequate maneuvering space or sink.

- Dianne's Kitchen – Leased space was only evaluated for site. Grate at entrance door exceeds allowable opening width.
- Dunn Arena – Accessible parking needs to be more clearly defined and signed. Doors have step at threshold. Electrical components are outside of reach range. Door hardware generally requires twisting and grasping. Doors also exhibit issues with closing speed and operating force. Inadequate signage is provided. At restrooms, non-compliances include lack of insulation, inadequate stall door hardware, stall width, toe clearance, and improper height of mirror and coat hooks. No special access equipment is provided at showers.

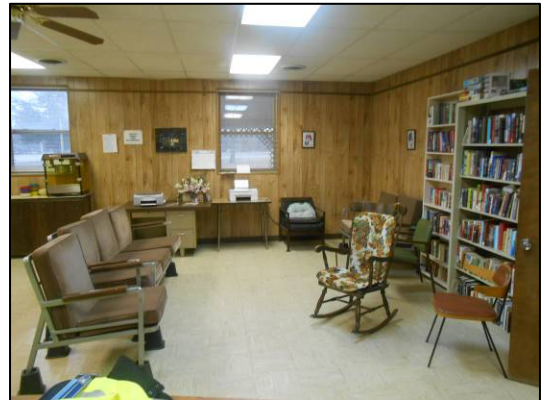
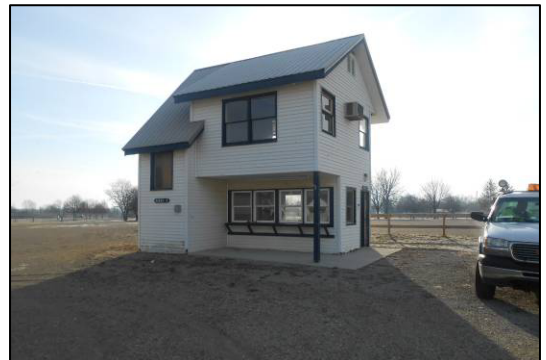
- Arena 5, Stabling Area, Cross Country Course – No accessible route provided. No barrier free parking provided. Accessible work surface is not provided at entry booth. Electrical components are outside of reach range. Stairs to announcer

exceed allowable riser height and do not provide handrails.

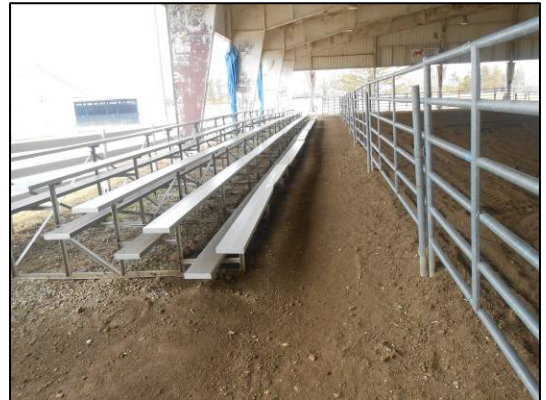
- General - Due to the nature of the Park's use, most general parking is not permanently designated and frequently occurs on lawn. During large events, consider making any paved lots accessible parking only with temporary signage and allowing for access aisles. Consider designating accessible parking areas near high-use areas on a permanent basis. Majority of surfaces are gravel or grass. Roadways are frequently used as pedestrian routes during events.

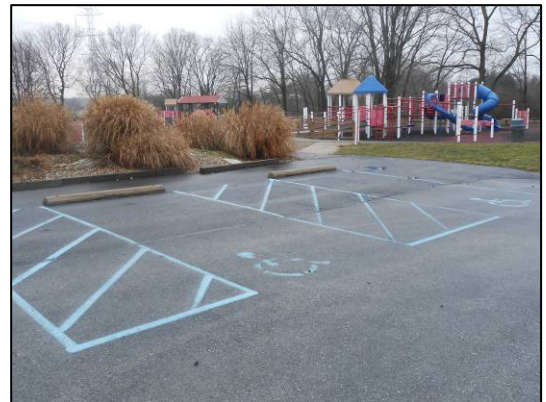
Independence Park

- Barrier free parking exhibits minor slope deficiency and lack of signage.
- Limited areas of paved trails and walks have slope or surface level issues.
- Restrooms lack water line insulation, wall signage, and grab bars. Minor dimensional issues exist in seat height and dispenser locations.

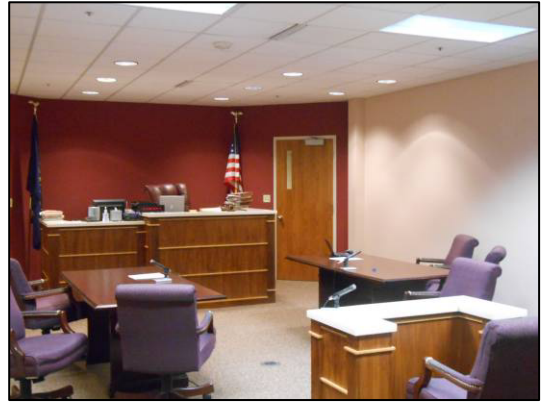
- Jury restrooms lack overall dimension to provide turning space and clear spaces required. No accessible features (such as grab bars) are provided.
- Courts do not provide or identify accessible aisle seating or companion seating. Inadequate number of assistive listening devices provided. No signage indicates system availability.

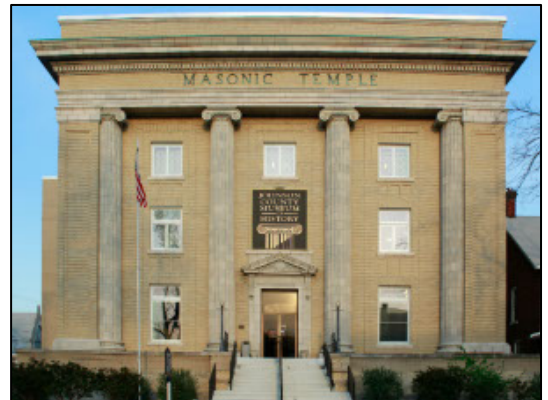
Johnson County Museum of History

- Barrier free parking signage is mounted at incorrect height.
- Accessible route is limited by presence of stairs.
- Door hardware is not compliant. Door closers frequently do not meet closing speed or operating force requirements. Main entry door exhibits issues with kick plate height and clear door width.
- Wall signage is not provided or does not meet requirements, including at stairways.
- Hi-Lo fountain is not provided.
- Restroom exhibits a number of minor dimensional deviations, including location of electrical components, toilet, mirrors, coat hooks and dispensers. Waterlines are not insulated. Urinals are not accessible. Stall width is inadequate. No grab bars are provided.

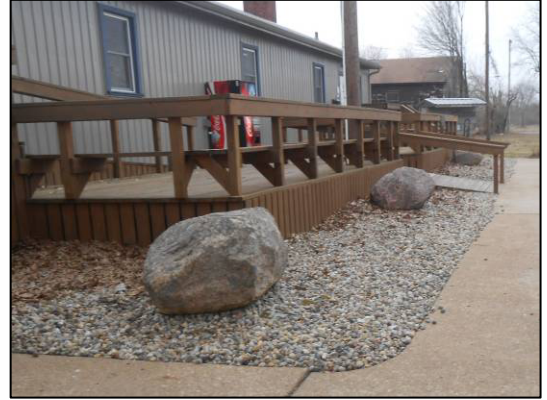
- Barrier free parking space and access aisle should be remarked and provided with signage.
- Edge protection is not provided at ramps. Handrails are non-compliant.
- Threshold exceeds allowable height at both doors.
- Kitchenette does not provide accessible work surface or sink.
- Information center is a protruding object in main office. Fire extinguisher protrudes in conference room.
- Accessible service counter is not provided.
- Signage is not provided.
- Overall dimensions of all 3 restrooms are inadequate for conversion to accessible restrooms. Recommend investigating possible conversion of one restroom in order to provide adequate maneuvering clearances.
- Door hardware frequently requires twisting and grasping.
- Light switches are located above allowable reach range.
- Shelter and site furnishings are not on accessible route.

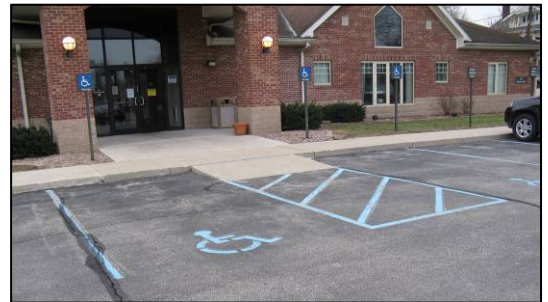
Prosecutor's Office

- Entry door cites issues with kick plate and maneuvering space for doors in series.
- Door closers frequently do not meet closing speed or operating force requirements.
- Hi-Lo fountain is not provided.
- Restroom exhibits a number of minor dimensional deviations, including location of electrical components and mirrors. Urinal is not accessible. Waterlines are not insulated. Stall width is inadequate. No grab bars are provided.

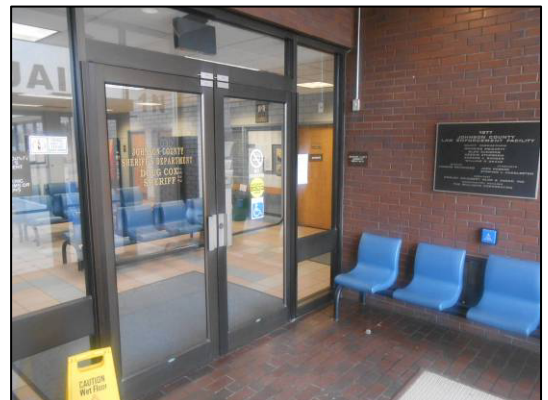
Sheriff/Jail/911 Center/Emergency Management

- Curb ramp exceeds slope requirements. Passenger loading zone is lacking accessible route to building entry.
- Entry doors exhibit closing speed and operating effort issues as well as needing a kick plate at glazing, lower threshold and more room between doors in series.
- Restroom exhibits a number of minor dimensional deviations, including location of electrical components, toilet, mirrors, dispensers and side grab bar. Waterlines are not insulated and knee

space is not provided at lavatory. Stall width is inadequate. Rear grab bar is not provided. In some restrooms, inadequate turning space is provided.

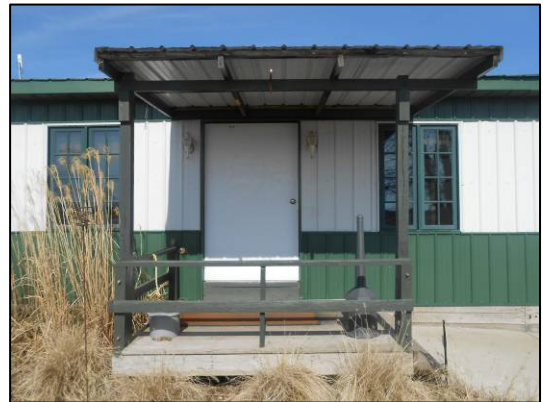
- Door hardware throughout clubhouse requires grasping and twisting. Accessible service counter is not provided.
- Signage is lacking or non-compliant at all doors.

- Restroom does not provide insulated water lines or grab bars. Dispensers and coat hook are mounted outside of reach ranges.

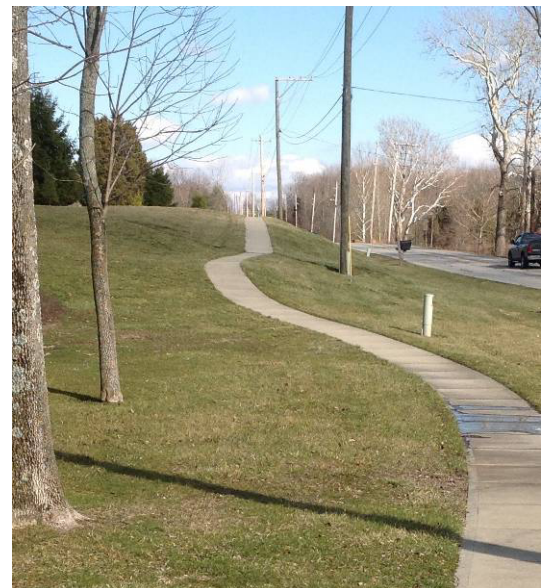
Example of +5% running slope exceeding roadway grade

- Lowering grade.
- Removing and regrading adjacent shallowly sloped panels to spread the slope over a greater run and achieve a more even, compliant slope throughout.

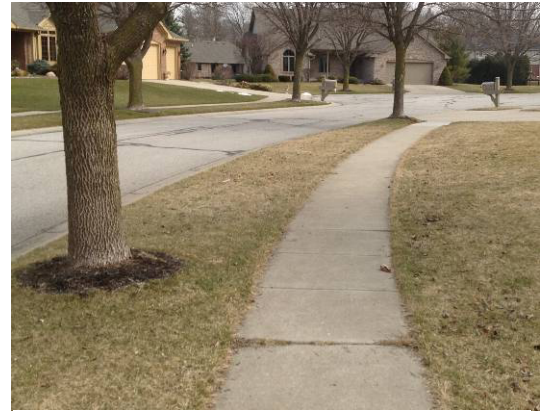
Example of displacement of sidewalk at tree

- Replacement of damaged concrete sidewalk panel
- If asphalt surface such as multi-use trail, mill and overlay with new surface
- Maintenance to keep free of vegetation and debris

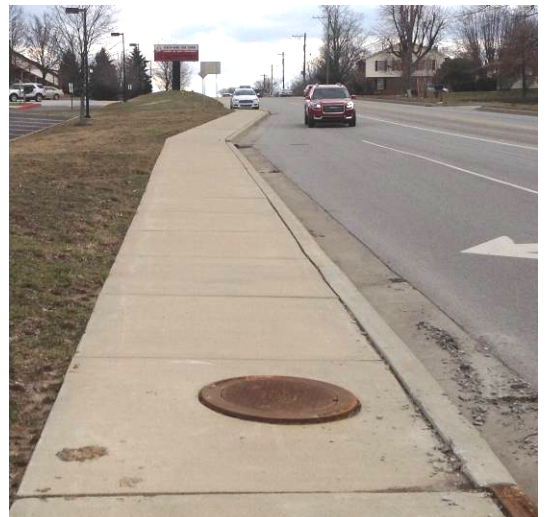
Example of displacement at utility

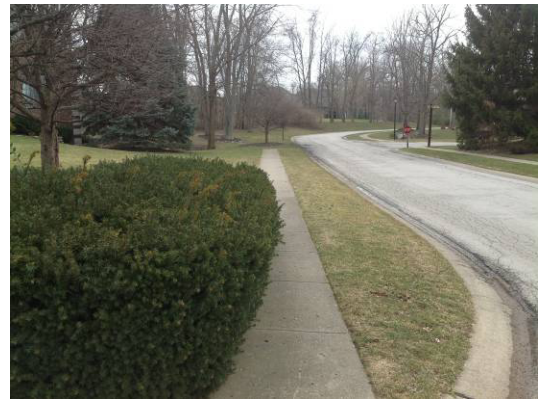
Example of vegetative obstruction

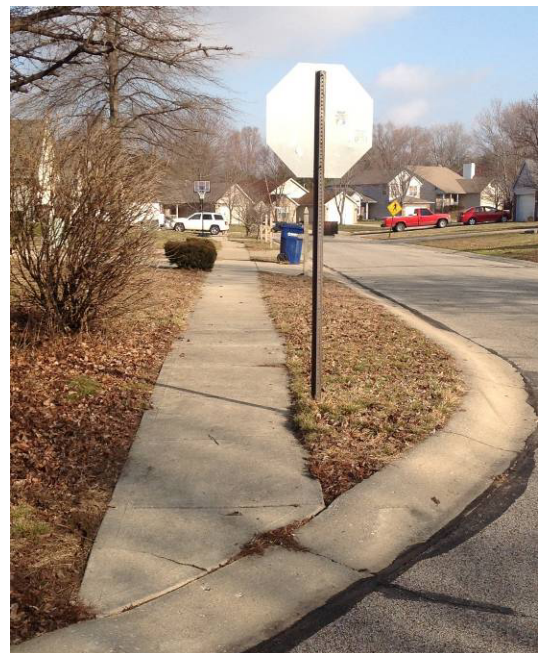
Example of signage protrusion

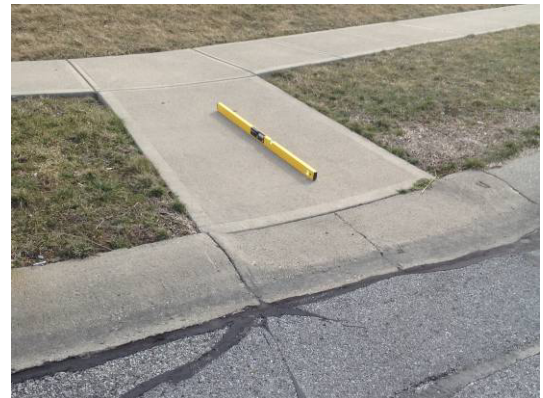
Example of running slope measurement

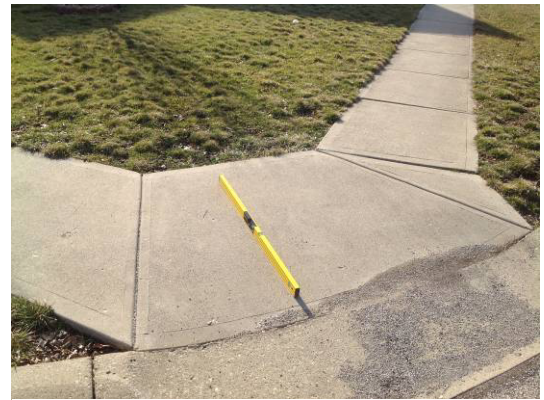
Example of lack of turning space and landing

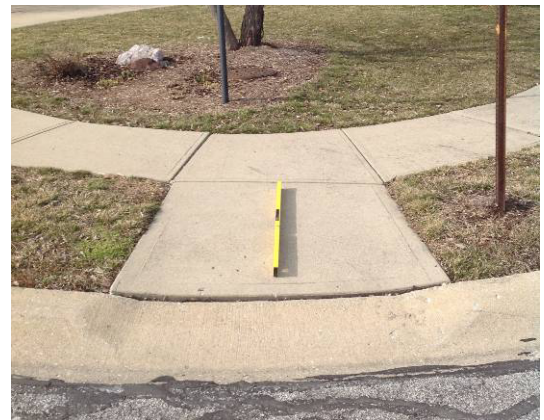
Example of good landing and turning space around street corner

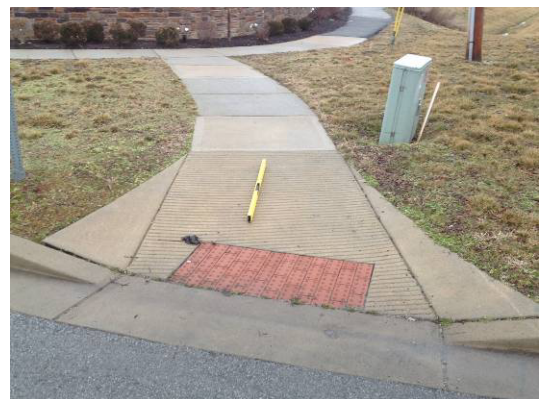
Example of DW that does not extend full width of curb ramp

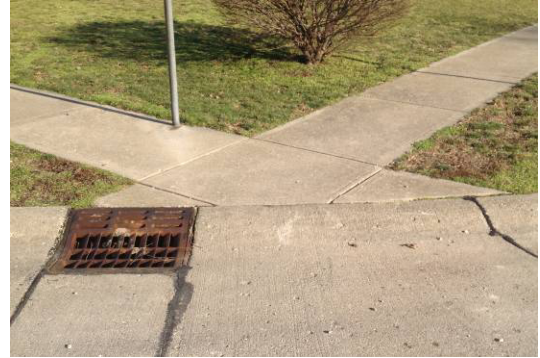
Example of poorly located drainage structure, lack of ramp, and a non-compliant grate

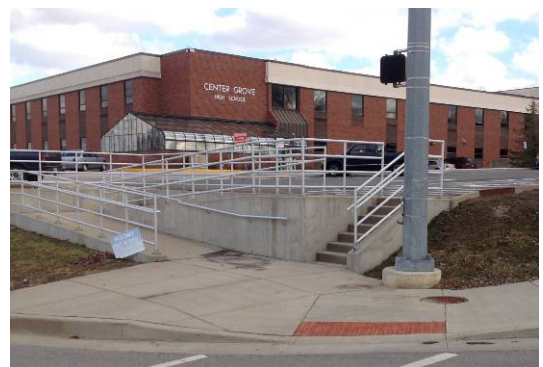
Example of utility pole obstructing ramp landing

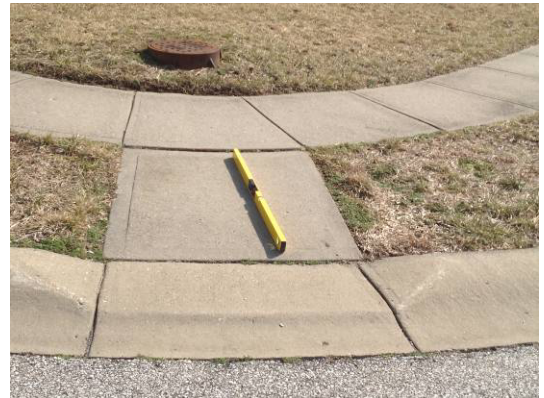
Example of $+\frac{1}{2}$ " displacement at gutter line and horizontal displacement at top of ramp

- Replacement of damaged ramp panel
- Maintenance to keep free of vegetation and debris

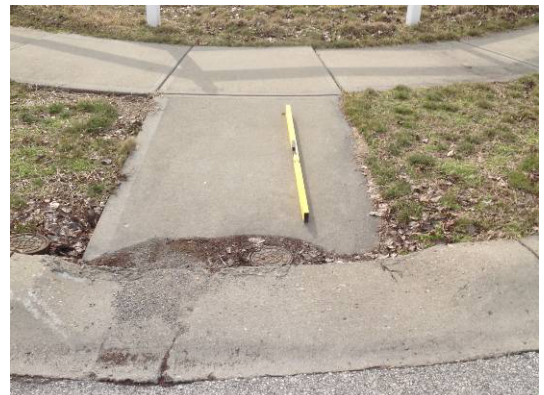
Example of settlement at curb and utility along with degradation of pavement
